6.0 Turner Hole Watershed

6.1 General Description

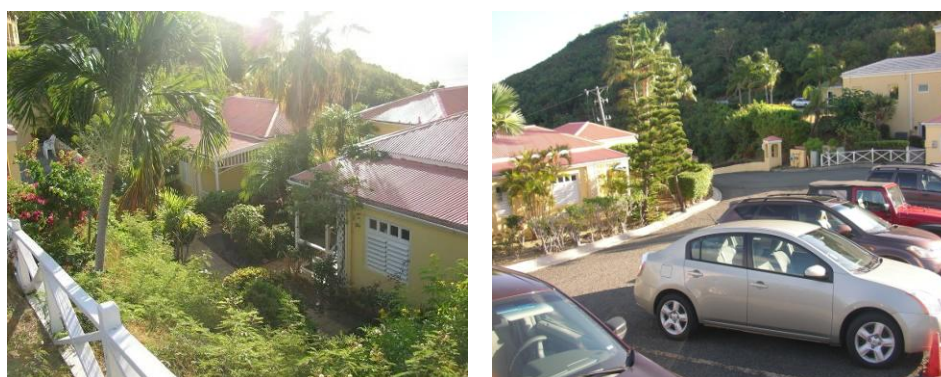
The Villa Madeline luxury condominiums are located on the ridgeline between the Teague Bay and Turner Hole watersheds. Villa Madeline is a gated community and is accessed by Maggie Hill Rd. off East End Rd./Rt. 82 on the north shore, and by South Ridge Rd. of South Shore Rd./Rt. 60. Approximately six of the 43 units are located on the Teague Bay side of the drainage divide, and all runoff from these units and the community building and management office drain north to Maggie Hill Rd. above Reef Golf. The remaining units are located within the Turner Hole watershed and drain to a small detention structure located behind the condo units, east of the tennis court. Roadways within the condominium complex are entirely paved and curbed and in good condition. Road runoff is either diverted to a small shallow concrete swale that runs the length of the west side of the main drive or sheet flows over land downhill to the bioretention area. Runoff from the rooftops and gutters appears to discharge directly on the paved surfaces, though this could not be fully confirmed. It mostly likely sheet flows over the roadways to the existing detention facility. Average lot cover is approximately 10% turf, 20% landscaping, 60% rooftop, and 10% driveway and walkways. All sewage is directed to an on-site wastewater treatment system. This residential community does not appear to be a source of significant pollutants and/or sediment and no recommendations are suggested (Figure 6.10).

Figure 6.10. Condominium units and portion of parking area at Villa Madeline.
